**FIVE-YEAR REVIEW
FINAL REPORT**

**POWERSVILLE LANDFILL SITE
POWERSVILLE, PEACH COUNTY, GEORGIA**

DECEMBER 1997

**Roy F. Weston, Inc.
5405 Metric Place, Suite 200
Norcross, Georgia 30092**

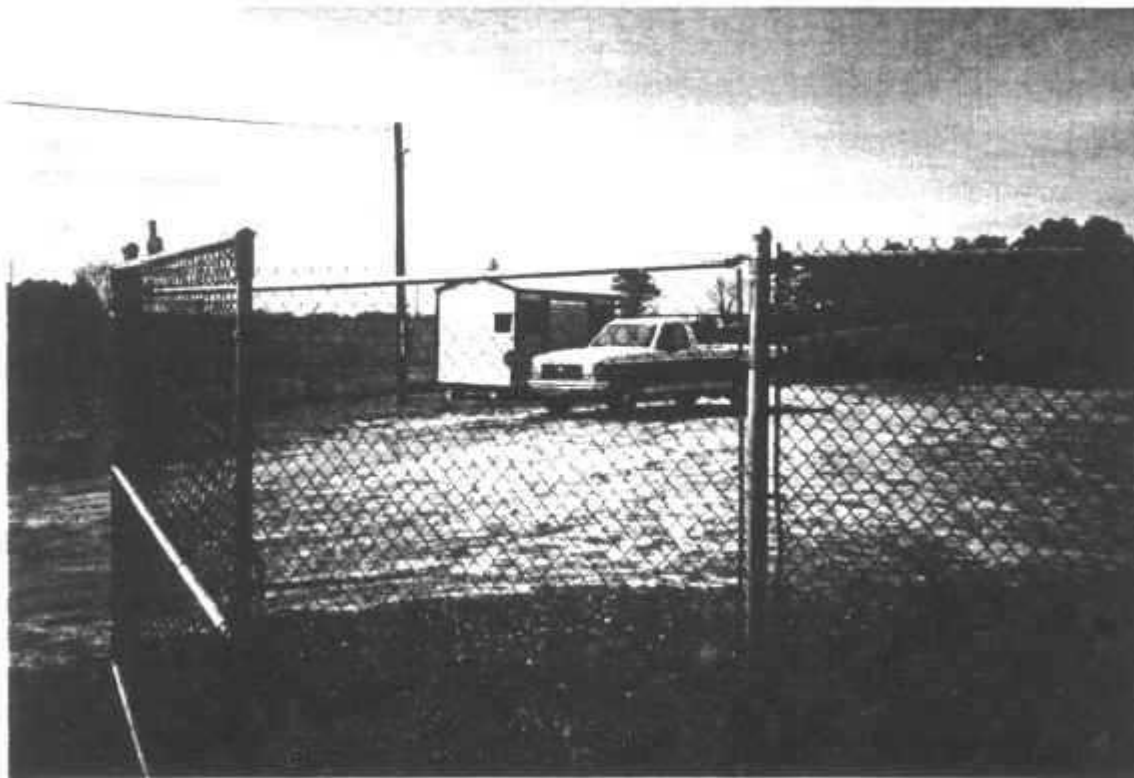
Photograph No. 1

The following is a summary of WESTON's observations made during the site tour with references to photographs which are included as Appendix B of this report. The site is in a rural area with a solid waste transfer station situated adjacent to the site (Photograph No. 1). The transfer station is operated from Tuesday through Saturday of each week. Although the transfer station attendant has no formal obligation to monitor the landfill site, his presence is obvious to any potential trespasser.
